# Hydro-Blasting Paint Removal

## Michigan - August 2019

Strength H2O completed a hydro-blasting paint removal project for a Private Client in Michigan.

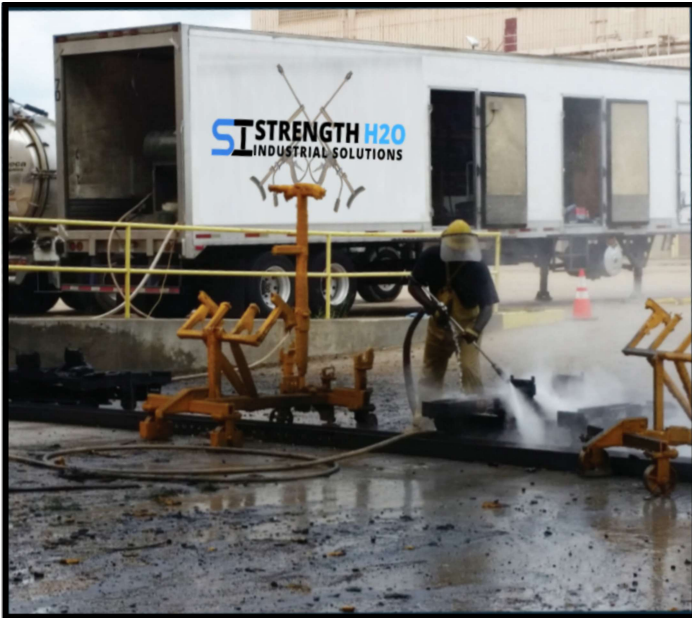
**ABOVE:** Blasting of the chassis carts with 40k psi hydro-blaster.

Strength H2O also cleaned front and rear chassis carts. These carts were also cleaned with 40k psi hydro-blasting. Previously, the process took four (4) hours to complete; Strength was able to fully clean the carts in an average of twelve (12) minutes.

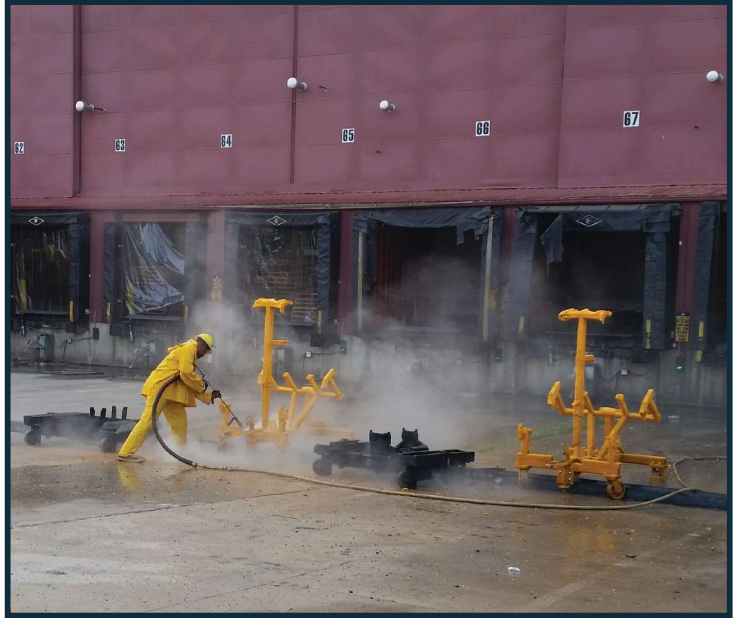
**ABOVE:** 40k psi hydro-blasting of the paint carts.

The Client manufacturers large vehicles and had been encountering long cleaning time issues with their paint carts. It would take as long as twelve (12) hours to clean a single cart. As a result, several of the carts had not been cleaned in four (4) years. Waste Solutions utilized 40k psi hydro-blasting to clean the paint carts. Comparatively, this process took as little as forty-five (45) minutes to clean each cart. Once the cart was cleaned, excess water was vacuumed and debris cleaned up. During off loading, the water was filtered to collect paint and debris, which was loaded into drums for disposal.

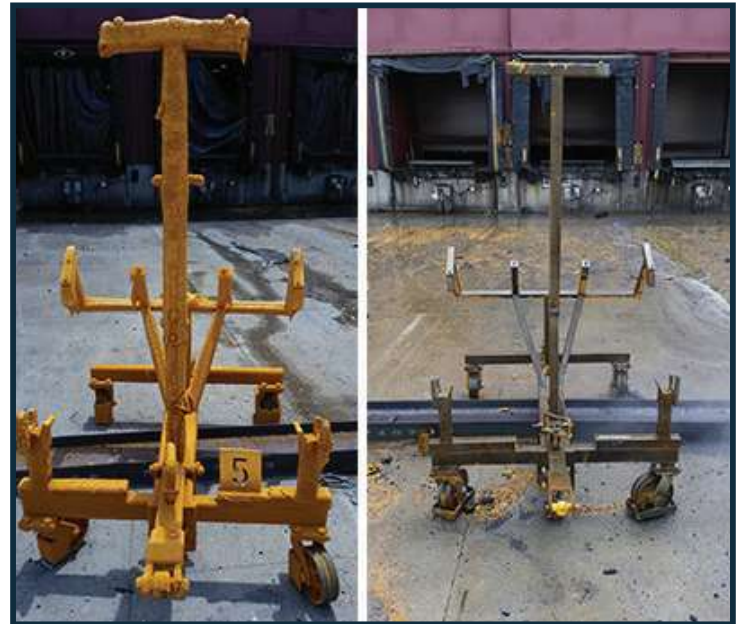
**ABOVE:** (L) Before and (R) after photos of paint cart.
